**Flood Control Project Maintenance  
Levee Inspections**

**Fall 2016 Levee Maintenance Deficiency Summary Report**

**Eastern Honcut Creek**

**Levee Inspection Report By Mile - Fall 2016**

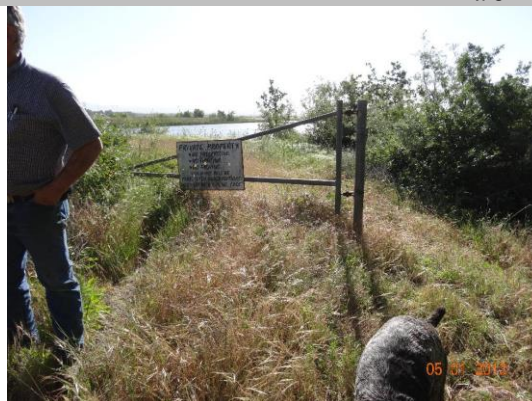
Photo 1 of 2 : UCIP\_FA\_2016\_14731\_24228.jpg

LM Start	0.01	Rating **	M	Issue No.	27
LM End	0.01	Issue Type +	En	Location *	N/A
Category	Supplemental			GPS Latitude/Longitude	
				Start	End
Item	DWR UCIP Field Study			39.298484 °	39.298484 °
				-121.569610 °	-121.569610 °
DWR ID					
Comment Code					
Inspector Comment					
FS_ID:14731					
DS_ID:19167					
EP_NO: N/A					
Repair Type: Non-Urgent					
Crossing Status: Found					
UCIP Comments: Dense vegetation on landward side obstructs inspection. Vegetation needs to be cleared to perform utility crossing inspection.					
FIELD_STRUCT_DESC: 24-inch corrugated metal drain pipe through the levee 12.0 feet below the crown. Flap gate on waterward end. Originally included the O&M manual, 1953.					
FS Date: 5/1/2013

View of crown looking east.

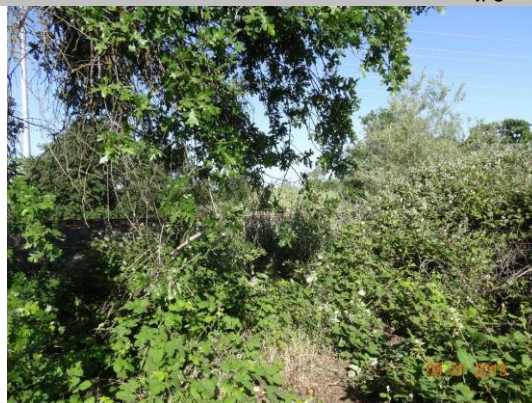
Photo 2 of 2 : UCIP\_FA\_2016\_14731\_24225.jpg

View of railroad looking west of crossing.

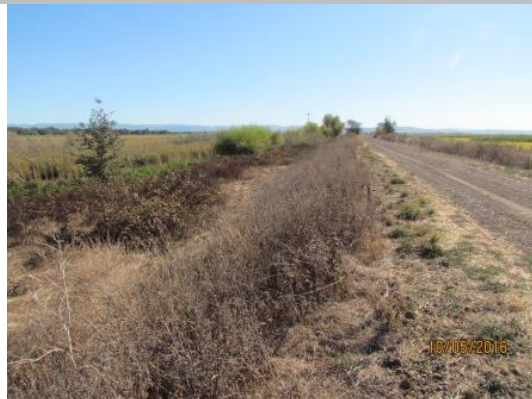
Photo 1 of 2 : FA\_2016\_NA0006\_252\_18\_20161005\_00031.jpg

LM Start	0.02	Rating **	M	Issue No.	18
LM End	1.45	Issue Type +	Ma	Location *	WS
Category	Earthen Levee			GPS Latitude/Longitude	
				Start	End
Item	Vegetation			39.298509 °	39.295263 °
				-121.569507 °	-121.546580 °
DWR ID	DWR_NA0006_01_f_2016_18				
Comment Code					
V1 : Control annual grass and weeds on the levee slopes and easements.					
Inspector Comment

View looking upstream waterside of annual vegetation that needs to be maintained. Fall 2016.

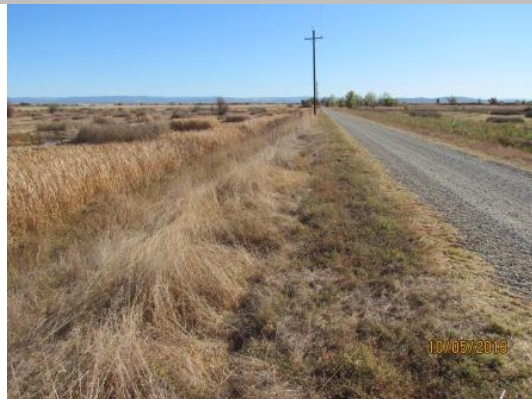
Photo 2 of 2 : FA\_2016\_NA0006\_252\_18\_20161005\_00032.jpg

Second view looking upstream waterside of annual vegetation that needs to be maintained. Fall 2016.

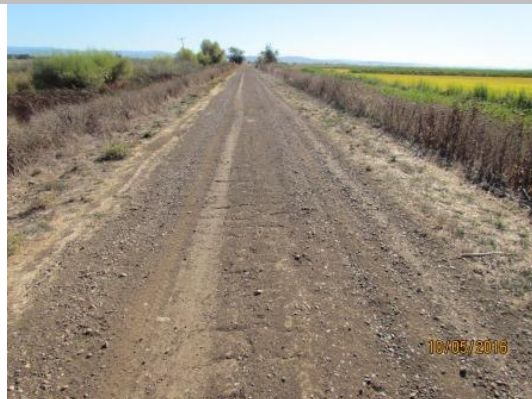
Photo 1 of 1 : FA\_2016\_NA0006\_252\_21\_20161005\_00033.jpg

LM Start	0.02	Rating **	U	Issue No.	21
LM End	0.66	Issue Type +	Ma	Location *	CR
Category	Earthen Levee			GPS Latitude/Longitude	
				Start	End
Item	Crown Surface / Depressions / Rutting			39.298504 °	39.297595 °
				-121.569502 °	-121.558310 °
DWR ID	DWR_NA0006_01_s_2015_21				
Comment Code					
C3 : Add appropriate gravel or road base. Grade and compact.					
Inspector Comment					
Place appropriate gravel on the crown roadway to make it an all weather road.

View of the crown looking upstream of a section of road that needs all weather surface. Fall 2016

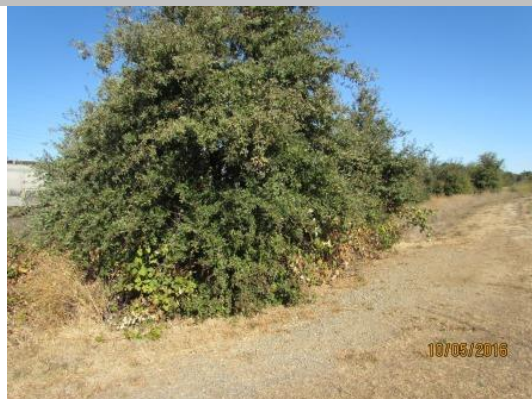
Photo 1 of 1 : FA\_2016\_NA0006\_252\_20\_20161005\_00025.jpg

LM Start	0.02	Rating **	U	Issue No.	20
LM End	0.02	Issue Type +	Ma	Location *	WS
Category	Earthen Levee			GPS Latitude/Longitude	
				Start	End
Item	Trim / Thin Trees			39.298563 °	39.298563 °
				-121.569432 °	-121.569432 °
DWR ID	DWR_NA0006_01_f_2016_20				
Comment Code					
T1 : Trim trees to at least five feet above ground level.					
Inspector Comment					
A tree that needs the limbs trimmed up 5' for visibility and access on the waterside. Fall 2016.

View of a tree that needs the limbs trimmed up 5' for visibility and access on the waterside. Fall 2016.

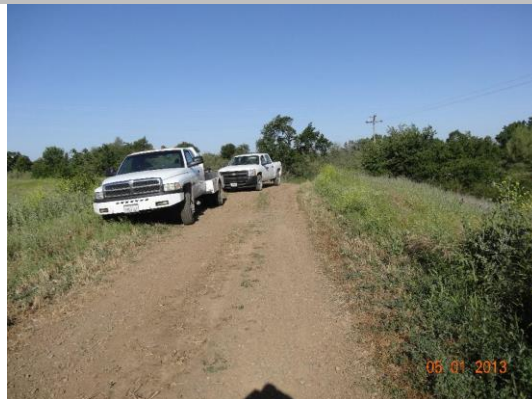
Photo 1 of 2 : UCIP\_FA\_2016\_14732\_24241.jpg

LM Start	0.09	Rating **	M	Issue No.	28
LM End	0.09	Issue Type +	En	Location *	WS
Category	Supplemental			GPS Latitude/Longitude	
				Start	End
Item	DWR UCIP Field Study			39.299106 °	39.299106 °
				-121.568749 °	-121.568749 °
DWR ID					
Comment Code					
Inspector Comment					
FS_ID:14732					
DS_ID:19168					
EP_NO: N/A					
Repair Type: Non-Urgent					
Crossing Status: Found					
UCIP Comments: Dense vegetation on waterward side and landward side obstructs inspection. Need to clear vegetation on slopes to conduct proper crossing evaluation.					
FIELD_STRUCT_DESC: 24-inch corrugated metal pipe through the levee 10 feet below the crown. Flap gate on the waterward end.					
Originally included in the O&M manual, 1953.					
FS Date: 5/1/2013

Overview of levee crown at crossing looking upstream.

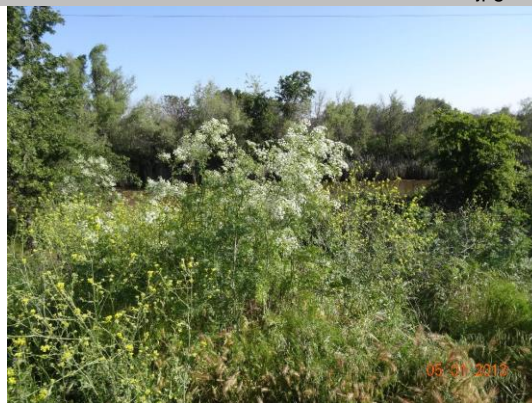
Photo 2 of 2 : UCIP\_FA\_2016\_14732\_24236.jpg

Dense vegetation obstructing waterward slope.

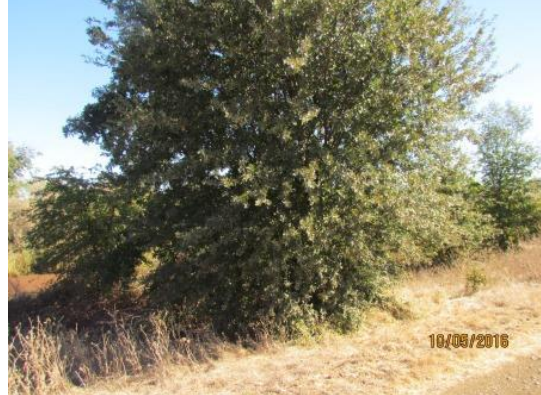
Photo 1 of 1 : FA\_2016\_NA0006\_252\_22\_20161005\_00026.jpg

LM Start	0.10	Rating **	M	Issue No.	22
LM End	0.10	Issue Type +	Ma	Location *	WS
Category	Earthen Levee			GPS Latitude/Longitude	
				Start	End
Item	Trim / Thin Trees			39.299078 °	39.299078 °
				-121.568633 °	-121.568633 °
DWR ID	DWR_NA0006_01_f_2016_22				
Comment Code					
T1 : Trim trees to at least five feet above ground level.					
Inspector Comment					
A tree that needs the limbs trimmed up 5' for visibility and access on the waterside. Fall 2016.

View of a tree that needs the limbs trimmed up 5' for visibility and access on the waterside. Fall 2016.

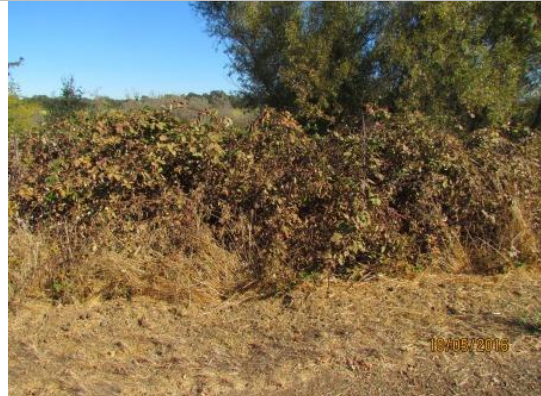
Photo 1 of 1 : FA\_2016\_NA0006\_252\_24\_20161005\_00034.jpg

LM Start	0.21	Rating **	U	Issue No.	24
LM End	0.24	Issue Type +	Ma	Location *	WS
Category	Earthen Levee			GPS Latitude/Longitude	
				Start	End
Item	Vegetation			39.298836 °	39.298768 °
				-121.566572 °	-121.565921 °
DWR ID	DWR_NA0006_01_f_2016_24				
Comment Code					
V2 : Remove the wild growth other than native grasses from the levee slopes.					
Inspector Comment					
Remove Blackberry bushes covering the waterside slope.

View of Blackberry bushes that cover the waterside slope. Fall 2016.

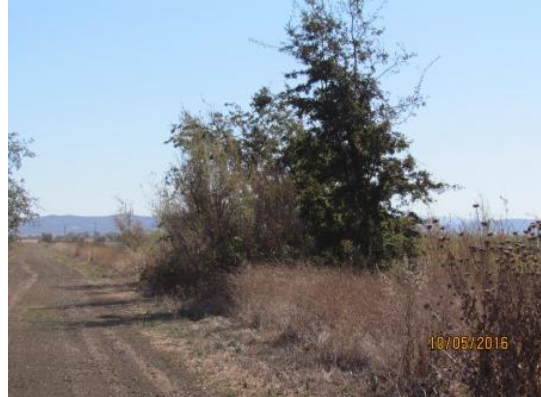
Photo 1 of 1 : FA\_2016\_NA0006\_252\_23\_20161005\_00027.jpg

LM Start	0.21	Rating **	U	Issue No.	23
LM End	0.21	Issue Type +	Ma	Location *	LS
Category	Earthen Levee			GPS Latitude/Longitude	
				Start	End
Item	Trim / Thin Trees			39.298816 °	39.298816 °
				-121.566529 °	-121.566529 °
DWR ID	DWR_NA0006_01_f_2016_23				
Comment Code					
T3 : Trim and thin trees to allow visibility of the ground and room to flood fight.					
Inspector Comment					
Trees that needs the limbs trimmed up 5' for visibility and access on the landside. Fall 2016.

View of trees that needs the limbs trimmed up 5' for visibility and access on the landside. Fall 2016.

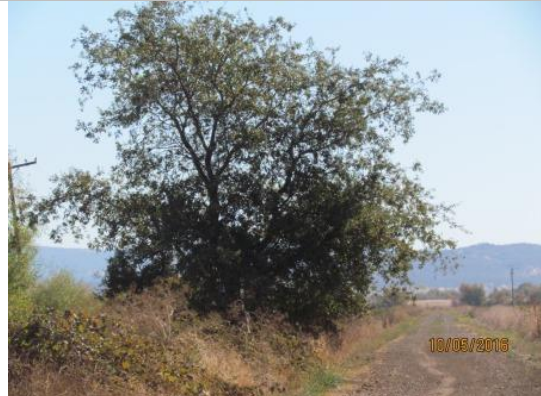
Photo 1 of 1 : FA\_2016\_NA0006\_252\_25\_20161005\_00028.jpg

LM Start	0.23	Rating **	M	Issue No.	25
LM End	0.23	Issue Type +	Ma	Location *	WS
Category	Earthen Levee			GPS Latitude/Longitude	
				Start	End
Item	Trim / Thin Trees			39.298776 °	39.298776 °
				-121.566158 °	-121.566158 °
DWR ID	DWR_NA0006_01_f_2016_25				
Comment Code					
T1 : Trim trees to at least five feet above ground level.					
Inspector Comment					
Tree that needs the limbs trimmed up 5' for visibility and access on the waterside. Fall 2016.

View of a tree that needs the limbs trimmed up 5' for visibility and access on the waterside. Fall 2016.

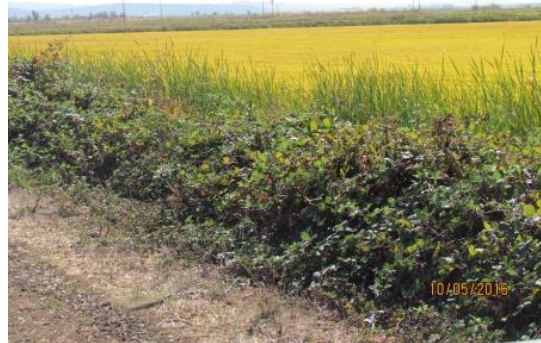
Photo 1 of 1 : FA\_2016\_NA0006\_252\_26\_20161005\_00035.jpg

LM Start	0.41	Rating **	U	Issue No.	26
LM End	0.41	Issue Type +	Ma	Location *	LS
Category	Earthen Levee			GPS Latitude/Longitude	
				Start	End
Item	Vegetation			39.298367 °	39.298367 °
				-121.562820 °	-121.562820 °
DWR ID	DWR_NA0006_01_f_2016_26				
Comment Code					
V2 : Remove the wild growth other than native grasses from the levee slopes.					
Inspector Comment					
Remove Blackberry bushes covering landside slope.

View of Blackberry bushes that cover the landside slope. Looking upstream. Fall 2016.

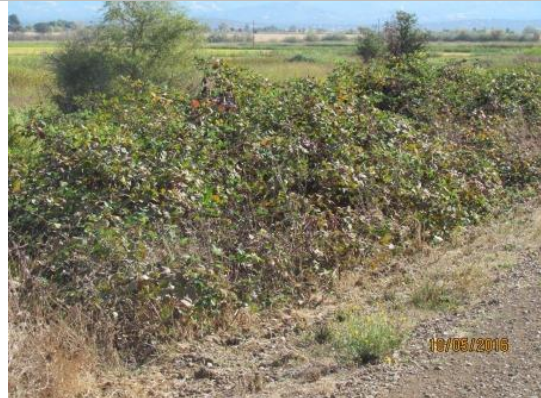
Photo 1 of 1 : FA\_2016\_NA0006\_252\_16\_20161005\_00036.jpg

LM Start	0.42	Rating **	U	Issue No.	16
LM End	0.45	Issue Type +	Ma	Location *	WS
Category	Earthen Levee			GPS Latitude/Longitude	
				Start	End
Item	Vegetation			39.298355 °	39.298280 °
				-121.562702 °	-121.562032 °
DWR ID	DWR_NA0006_01_f_2016_16				
Comment Code					
V2 : Remove the wild growth other than native grasses from the levee slopes.					
Inspector Comment					
Remove Blackberry bushes covering waterside slope.

View of Blackberry bushes that cover the waterside slope. Looking upstream. Fall 2016.

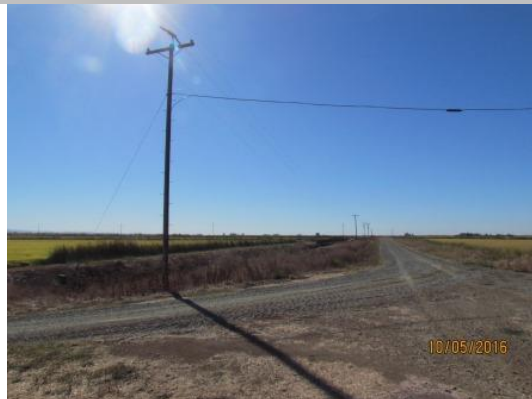
Photo 1 of 1 : FA\_2016\_NA0006\_252\_17\_20161005\_00038.jpg

LM Start	0.66	Rating **	M	Issue No.	17
LM End	1.45	Issue Type +	En	Location *	WS
Category	Earthen Levee			GPS Latitude/Longitude	
				Start	End
Item	Encroachments			39.297629 °	39.295257 °
				-121.558337 °	-121.546579 °
DWR ID	DWR_NA0006_01_s_2015_17				
Comment Code					
PO : Pole					
Inspector Comment

View of the poleline on the waterside of the levee facing upstream. Fall 2016.

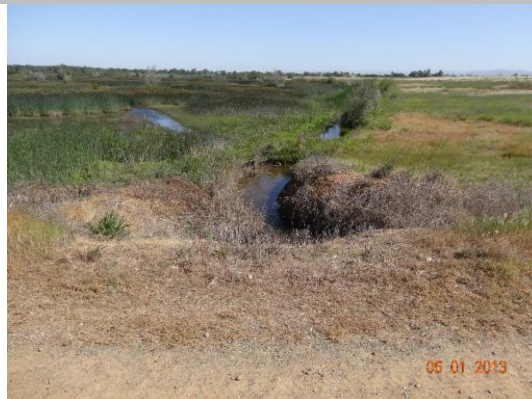
Photo 2 of 2 : UCIP\_FA\_2016\_14736\_24272.jpg

LM Start	1.44	Rating **	M	Issue No.	31 (cont)
LM End	1.44	Issue Type +	En	Location *	WS
Category	Supplemental			GPS Latitude/Longitude	
				Start	End
Item	DWR UCIP Field Study			39.295238 °	39.295238 °
				-121.546755 °	-121.546755 °
DWR ID					
Comment Code					
Inspector Comment					
FS_ID:14736 DS_ID:19169 EP_NO: N/A Repair Type: Non-Urgent Crossing Status: Found UCIP Comments: Need to determine permit authorizing work. FIELD_STRUCT_DESC: 18-inch corrugated metal pipe through the levee 8 feet below the crown. Slide gate on the landward end. Shot rock revetment on the landside near slide-gate. FS Date: 5/1/2013

View of waterward side.
